## Monitoring Data Record

Project Title: R-2248D – Charlotte Outer Loop COE Action ID: 200131321  
Stream Name: Trib. to Dixon Branch (Site 19) DWQ Number: 011231  
City, County and other Location Information: Mecklenburg County, Charlotte Outer Loop,  
R-2248D Left of Project Station 10+00 Y-7  
Date Construction Completed: May 2008 Monitoring Year: ( 2 ) of 5  
Ecoregion:  8 digit HUC unit 03050103  
USGS Quad Name and Coordinates:

# UT to Dixon Branch

## Site 19

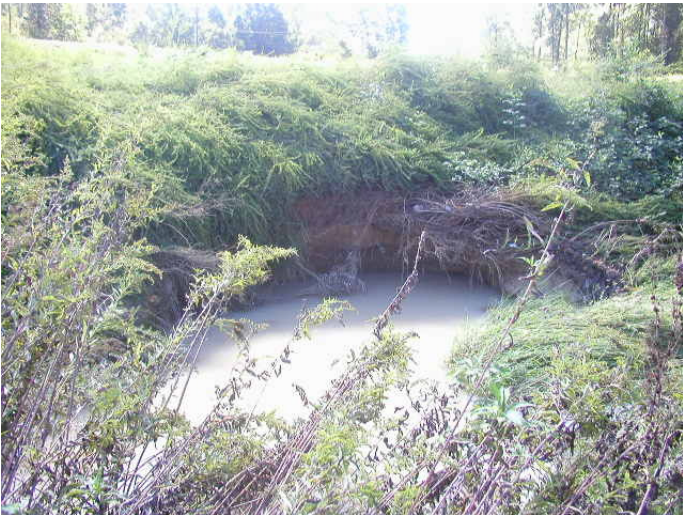
Date 9/28/10	Station 10+80 Y-7	Station 10+40 Y-7	Station 10+20 Y-7	Station Number	Station Number
Structure Type					
Is water piping through or around structure?					
Head cut or down cut present?					
Bank or scour erosion present?	Bank scouring on left bank	Bank scouring on left bank	Bank scouring on left bank		
Other problems noted?

Left bank scouring at end of J-Hook @ Sta. 10+80 Y-7

UT to Dixon Branch (Site 19) stream relocation is stable for the Year 2 Summer evaluation, except for, some areas of bank scouring that were noted upstream of the pipe crossing during this evaluation at Sta. 10+80, Sta. 10+40, and Sta. 10+20. NCDOT plans to install live stakes along the streambank to help stabilize these areas of scouring. The area downstream of the pipe that had extensive erosion was repaired during May 2010 (see photo point #4 upstream). A bankfull event had occurred since the last monitoring evaluation. NCDOT will continue to monitor channel stability at this stream relocation.

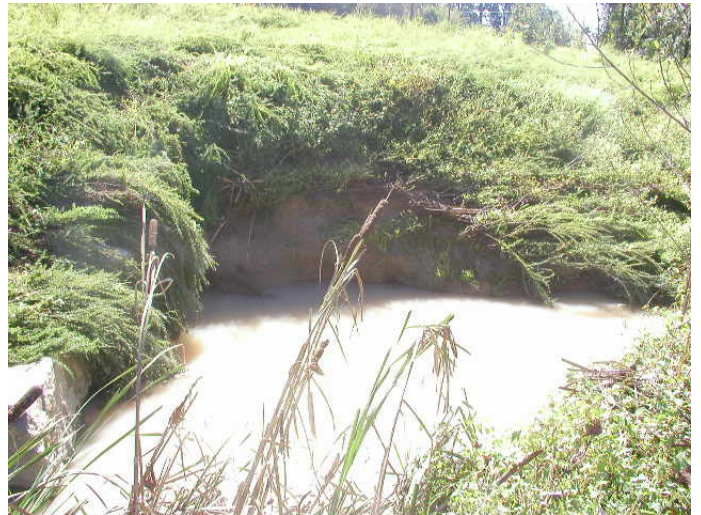
Left bank scouring at end of J-Hook @ Sta. 10+40 Y-7

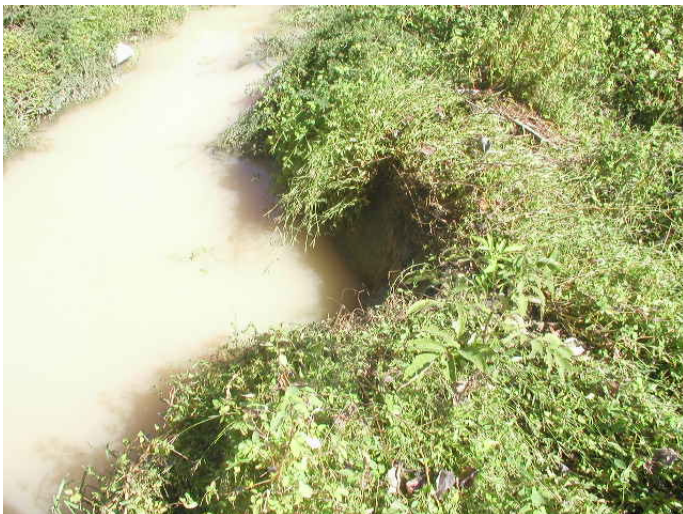
Left bank scouring near PP#3 @ Sta. 10+20 Y-7  
Year 2 Summer – September 2010
